Manhole Inspection Summary

Manhole # S15E1_009MH

Location Address: **2960 parkman av**

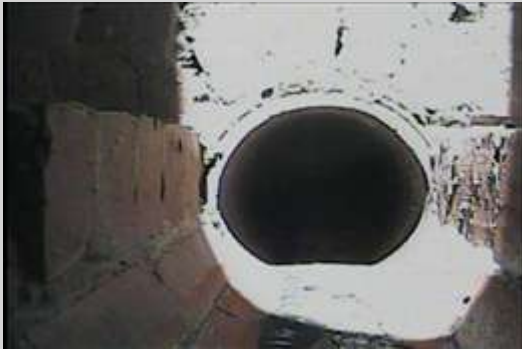
12 O'Clock Outflow

8 in. Circular Gravity Sewer
Pipe Out @ 12 O'Clock

Pipe Height: **8.4** (in.) Rod and Bar (Angled)
Pipe Material: **Clay** ☐ Pipe Lined
Invert Depth: **7.58** (ft.) Flow Characteristics: **Slow**
Deposits: ☒ None ☐ Mud ☐ Sludge ☐ Debris ☐ Grease
Silt Depth: **0** (in.) Deposits Extent:
Infiltration: **None** Pipe Seal Cond: **Sound**
